Structural Integrity Assessment of an Abandoned Reinforced Concrete Structure

Abstract. This paper presents details of findings for the structural integrity assessment of an abandoned building located in the southern part of Nigeria. Construction work on the uncompleted building commenced in June 2010 with the foundation laying and progressed up to the first-floor slab before work was abruptly suspended. The investigation was aimed at providing the relevant technical information to enable work on the project to resume safely. The investigation involved excavation to expose selected foundations, visual observations and non-destructive tests to determine the compressive strengths of reinforced concrete elements. The results showed the mean strengths of the existing structural members ranging from 23.47 to 29.93 N/mm².

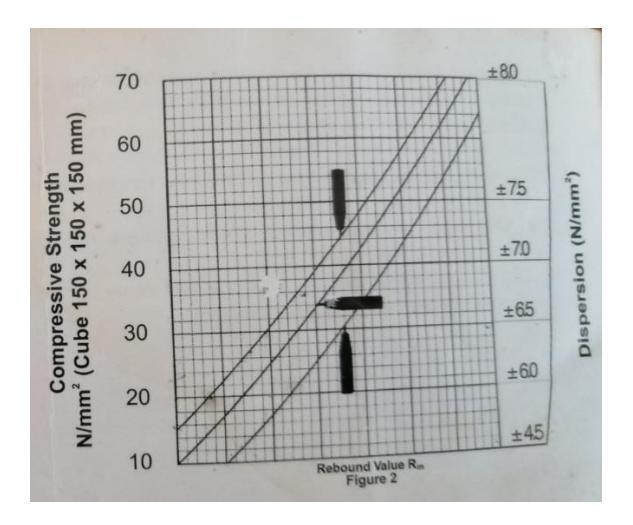
Figure 1: Chart for determining compressive strength (N/mm^2) [11]

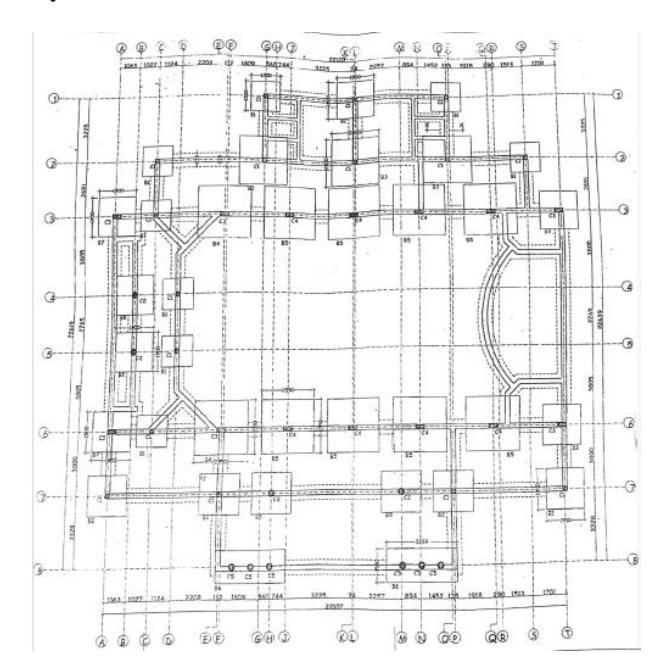
The references in this report for locating structural elements of the existing structure were based the design

structural grids shown in Figure 2 for foundation/column layout.

Figure 2: Foundation/column layout

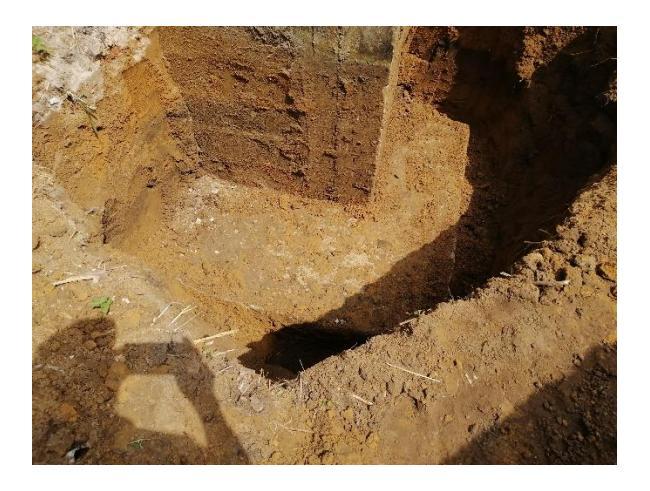
As shown in Figures 3 and 4, two external pad foundations were excavated in order to determine their dimensions and compressive strength of concrete used.

At grid node A3, the pad foundation was located at a depth of approximately 1.73m below ground level, while the plan area was approximately 1630mm by 1800mm with a thickness of 400mm. The structural design identified the foundation as *Foundation Base Type 7* and showed dimensions as 1900mm by 1900mm with a thickness of 400mm. The actual provision of plan area was therefore less than the design provision.

At grid node T3, identified in the structural design as *Foundation Base Type 3*, the foundation plan size was 2400mm by 2400mm in line with the structural design. However, the actual thickness was approximately 350mm, while the design provided for 450mm.

Figure 3: Excavated foundations to reveal pad foundations

- ii. Foundations may be checked further, though there were no visible signs of uneven settlements.
- iii. Subsequent concrete work should be done using kickers to ensure that the designed concrete covers were maintained. Where steel bars are exposed due to inadequate covers, the steel should be protected using cement mortar plaster or grouts.

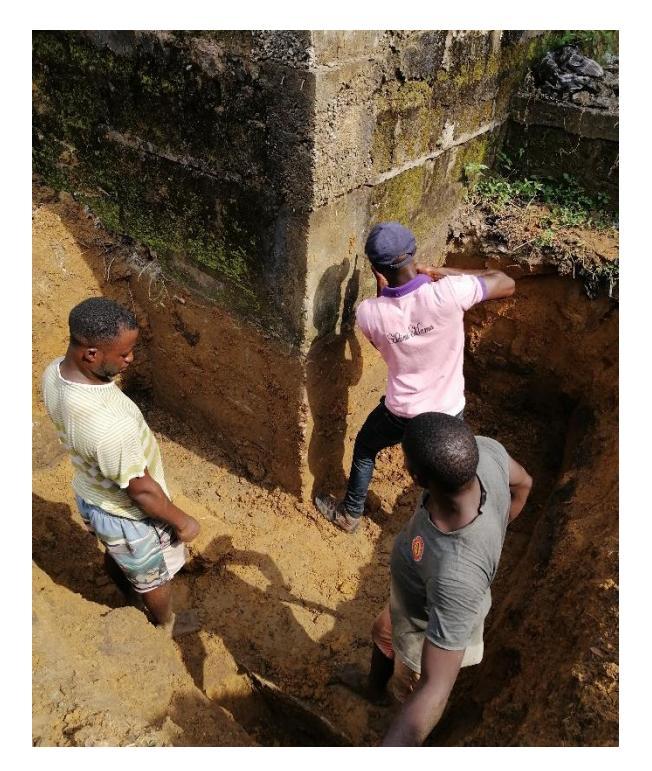
Figure 4: Excavated foundations showing rebound hammer concrete test in progress.

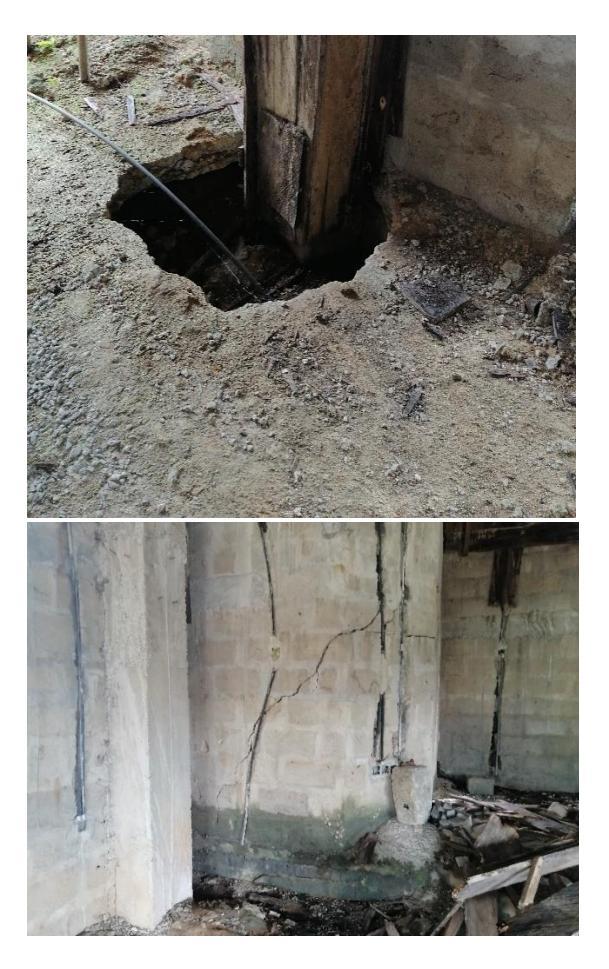
Internally, it was observed that pad foundations were introduced to the enlarged columns on grid lines 3 and 6, from F to Q, using the grid numbers on the structural foundation layout (Figure 2). Excavated concrete floor to introduce such foundation for grid point K2 was yet to be filled. The side of the enlarged columns were found to be 500mm x 500mm. Similar work at K3 was observed to be the possible cause of cracks found on adjacent wall (See Figure 5).

Figure 5: Enlarged columns and excavated pit for foundation and cracks on adjacent wall.

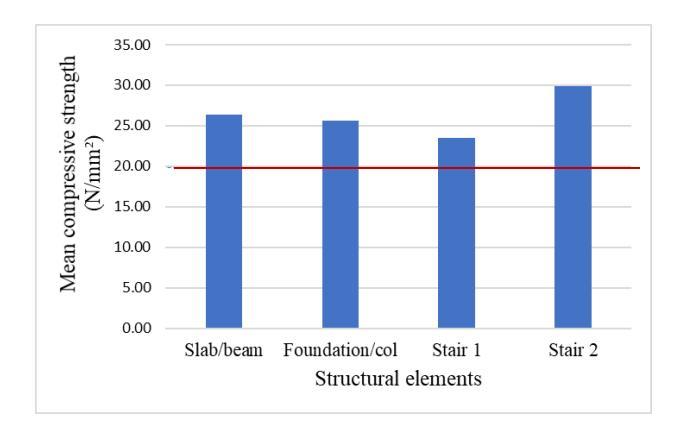
The summary of average compressive strengths measured for all elements are shown in Table 3. The average compressive strength of the foundation/column concrete was investigated using non-destructive Rebound Hammer test. The foundation/columns concrete mean compressive strength was 25.66N/mm². Generally, the compressive strength results for all the elements were found to meet the design strength of 20.0N/mm² used in the structural design. Figure 6 shows that the mean compressive strengths for all the structural members were greater than the design strength of concrete.

Figure 6: Mean compressive strengths for various structural elements

The average compressive strength of concrete for the two stairs were found to be 23.47 ± 0.76 and 29.93 ± 1.85 N/mm² respectively. As shown in Figure 6, these values are greater than the design strength of 20N/mm².

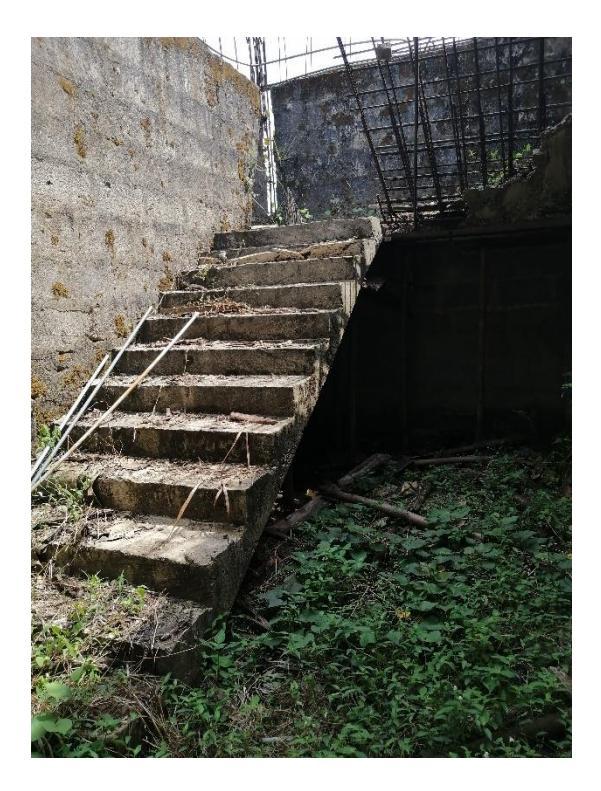
They were 3 stairs found which were partially completed. The stairs at grid 2-3/C-G and 6-7/A-F, of the three stairs had concrete cast for first flights and landings only (Figure 7). The third had only steel reinforcement in place. The completed portion of the concrete stairs had as built approximate dimensions are shown below:

Figure 7: State of stairs observed during site visit

The range of values in the measurement reveal irregular dimensions of the concrete steps. From the uncast portion of the stairs, the steel reinforcements were found to be approximately 12mm diameters spaced at 150 - 200mm for main bars and spacing of 200 - 250mm centers for distribution bars.

- i. The areas where steel reinforcement bars were still exposed should be covered by completing all outstanding casting of concrete at the first-floor level and staircases, to prevent adverse corrosion of the rebars.

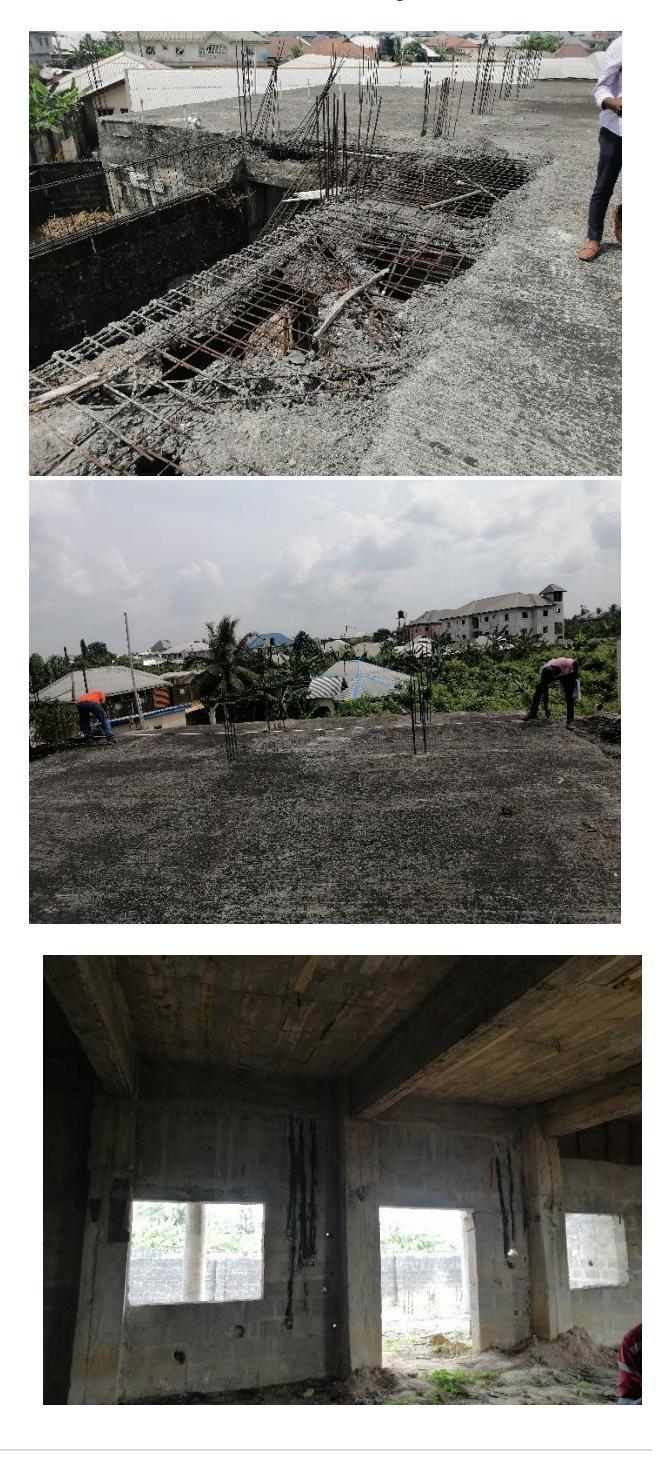
The concrete solid slab thickness was estimated to range between 150mm to 200mm as measured from exposed sides adjacent to the stairs. The design thickness for slab deck was found to be 150mm.

The slab steel reinforcements were 12mm diameter high yield steel placed at 150mm centers both directions for

bottom bars and spacing of 300 - 350mm for top bars. Concrete cover to steel reinforcement was approximately 25mm.

As indicated in Tables 2 and 3 earlier, compressive strength was obtained from 71 test points spaced approximately 1 - 2m. The average compressive strength of the concrete slab was found to be 26.33 ± 1.87 N/mm². Also, from physical observation the slab deck did not show any noticeable vibrations. The existing conditions of the first-floor slab are shown in Figure 8.

Figure 8: Completed First floor slab (top/under) and uncompleted portion

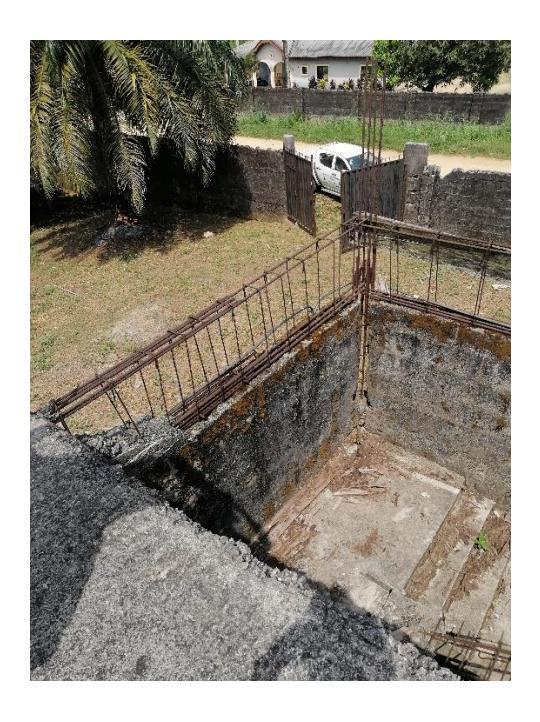
Similarly, beam 26 (gridline T/3-6) was 230mm x 750mm concrete section. As observed from the uncompleted sections of the beam, the steel reinforcements were 6T20+4T12 (bottom) and 5T16 (top). Links were T8 @ 250mm centers. The design provided 2T16 top and 5T20 bottom. Generally, the steel provisions for the beams observed were either similar or above design provisions. Some exposed beam reinforcements are shown in Figure 9.

Figure 9: Exposed beam reinforcement yet to receive concrete cast

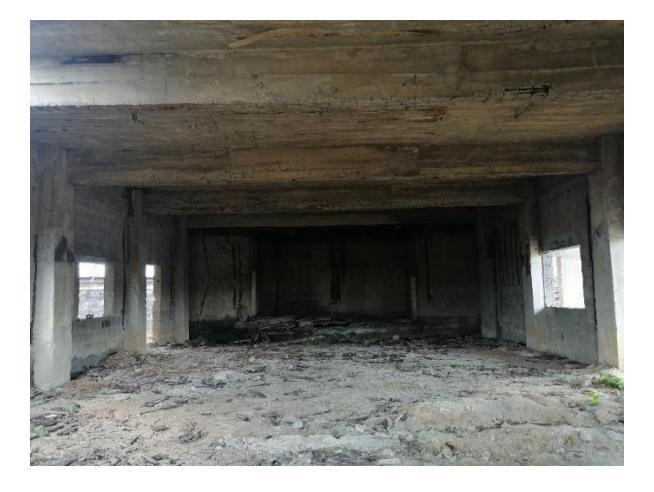
Some completed beams show exposed steel reinforcements bars and honey combs. Some sections of completed structural members viewed internally from the auditorium are shown in Figure 10.

Figure 10: Underside of completed 1st floor slab and beams viewed from the auditorium, showing exposed steel bars under threat of corrosion.

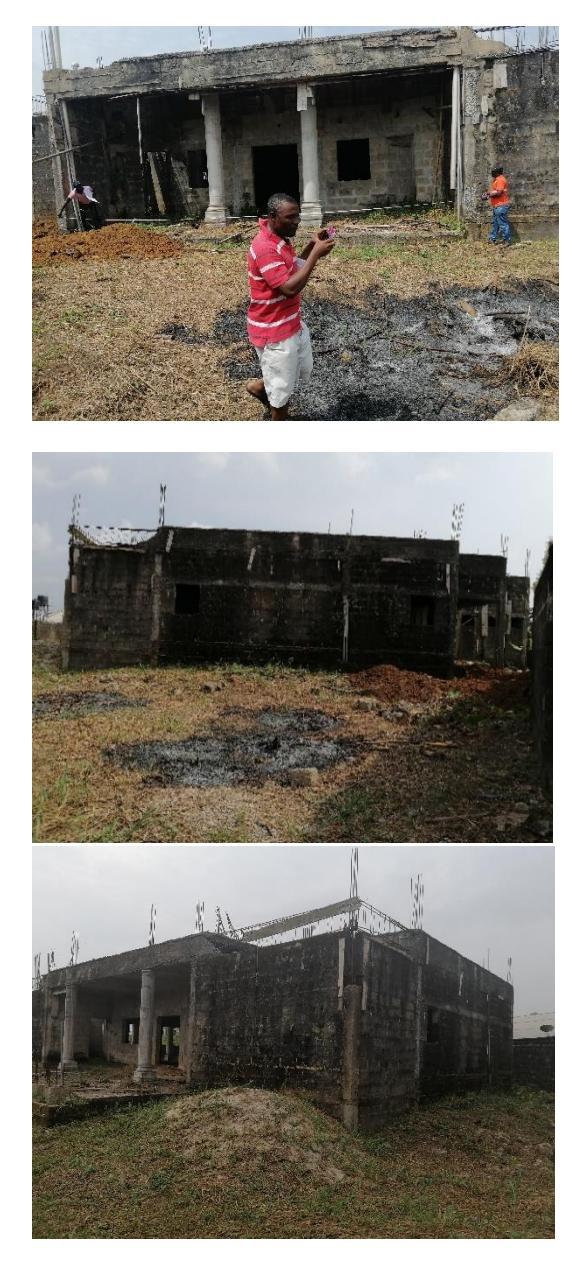
Figure 11 shows external conditions of the main structure, while Figure 12 shows structural members and their steel reinforcement bars, where concreting was not completed or executed.

Figure 11: Different external views of the state of completed works

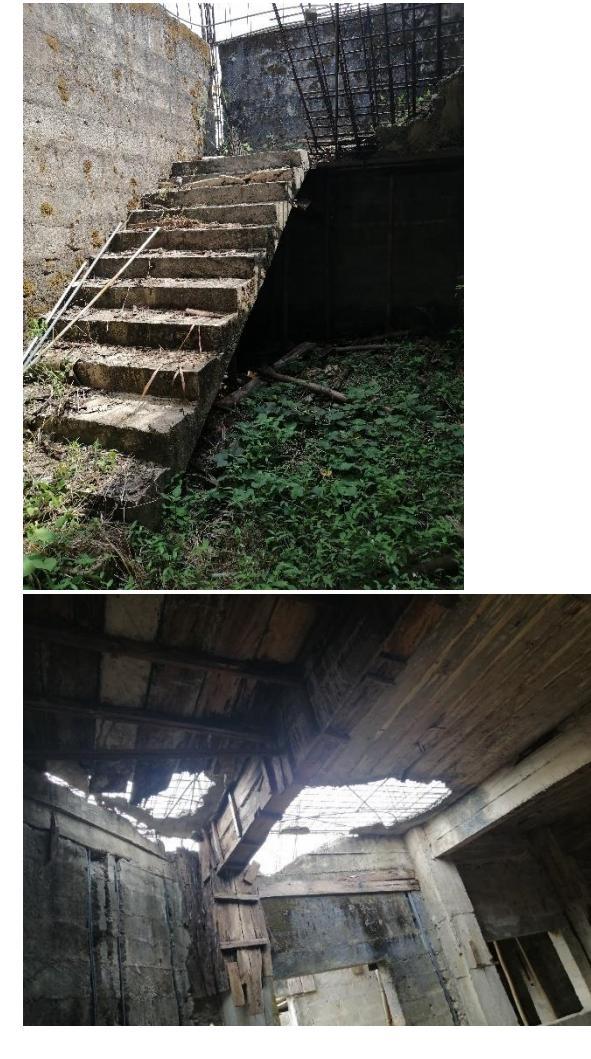
Figure 12: Uncompleted concreting of staircases and first floor slab viewed internally

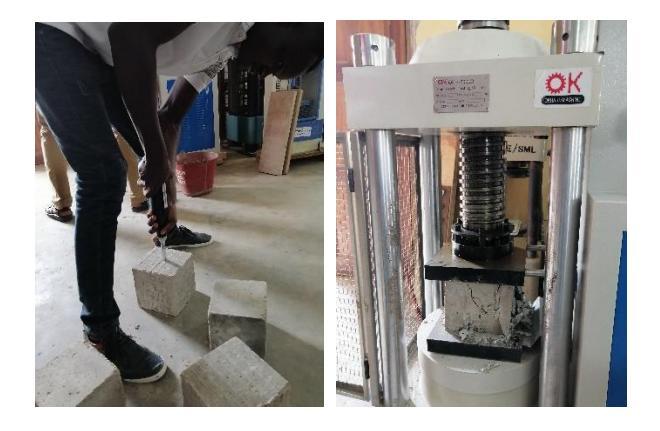
The results of concrete rebound hammer tests were compared with those of compression machine in the laboratory using concrete cubes, in order to validate the field tests. Figure 13 shows the tests progress in the

Figure 13: Laboratory tests on concrete cube samples to establish relationship between compression machine and rebound hammer.

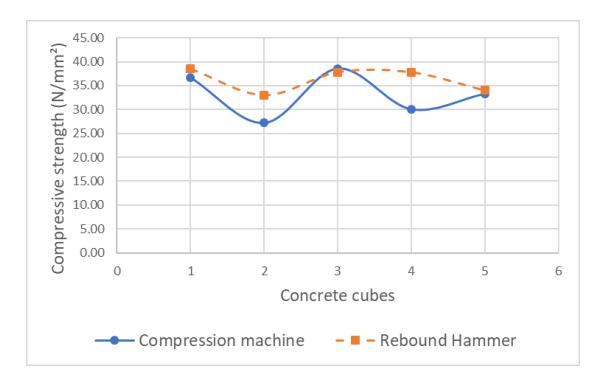
laboratory, while Figure 14 shows the relationship between compressive strength values obtain from compression testing machine and rebound hammer. A positive correlation coefficient of 0.65 was obtained. The results also show that the rebound hammer slightly overestimates the compressive strength for all the cubes except one. The average difference was approximately 3.0 N/mm² which was used to correct the results obtained from the field.

Figure 14: Relationship between compressive strengths of concrete cubes obtained from compression machine and rebound hammer
